Quality Assurance and Source Inspection

Contract #: 04-0120F4Cty: SF/ALA Rte: 80 PM: 13.2/13.9File #: 69.28**WELDING INSPECTION REPORT****Resident Engineer:**Siegenthaler, Peter**Address:** 333 Burma Road**City:** Oakland, CA 94607**Report No:** WIR-020806**Date Inspected:** 29-Oct-2010**Project Name:** SAS Superstructure**OSM Arrival Time:** 700**Prime Contractor:** American Bridge/Fluor Enterprises, a JV**OSM Departure Time:** 1900**Contractor:** Zhenhua Port Machinery Company, Ltd (ZPMC), Changxing Island **Location:** Shanghai, China**CWI Name:** Li Yan Hua**CWI Present:** Yes No**Inspected CWI report:** Yes No N/A**Rod Oven in Use:** Yes No N/A**Electrode to specification:** Yes No N/A**Weld Procedures Followed:** Yes No N/A**Qualified Welders:** Yes No N/A**Verified Joint Fit-up:** Yes No N/A**Approved Drawings:** Yes No N/A**Approved WPS:** Yes No N/A**Delayed / Cancelled:** Yes No N/A**Bridge No:** 34-0006**Component:** OBG Segment Assembly**Summary of Items Observed:**

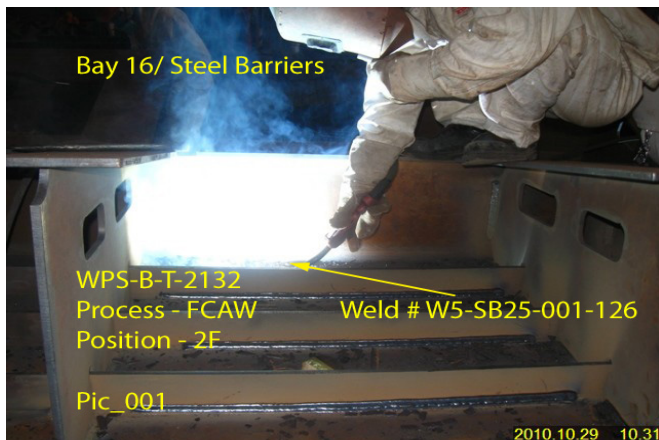
Flux Core Arc Welding (FCAW) in the 2F position of W5-SB25-001 Steel Barrier internals weld # W5-SB25-001-126. The welder is identified as 066751. ZPMC Quality Control (QC) is identified as Guo Pin. The welding variables recorded by QC appeared to comply with WPS-B-T-2132. See attached photograph Pic_001.

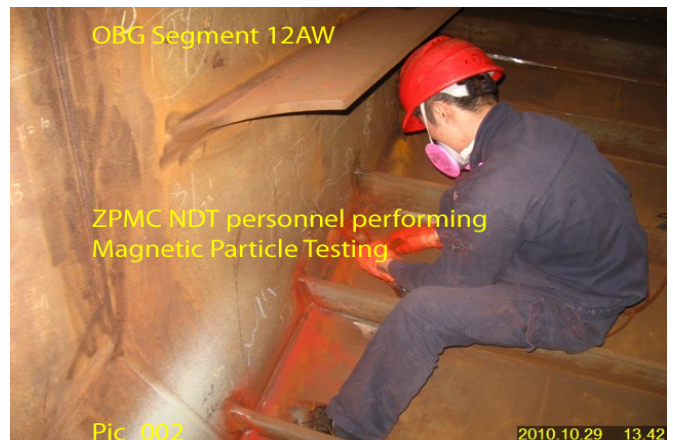
During in process inspection this QA Inspector observed ZPMC NDT personnel performing Magnetic Particle Testing (MT) on Cross Beam side Corner Assembly SP to PP110 West welds. See attached photograph Pic_002.
